IP67 现场总线端子盒的 IP-Link 通讯故障排除后的自动恢复

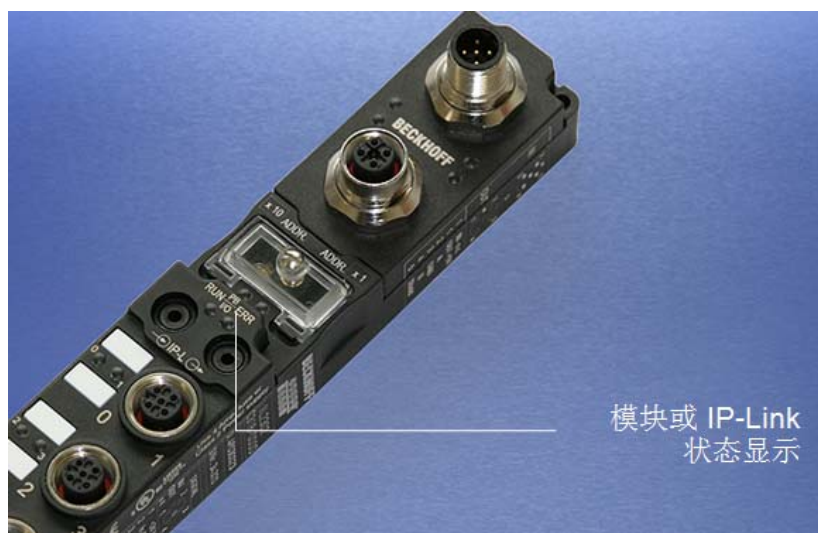
图 1: IP-Link 通讯状态指示灯

IP67 模块 IP-Link 通讯发生故障后，通过查看其 IP-Link 状态指示灯（图 1）的闪烁或亮灭配合对应的表格（图 2）即可判断具体故障信息及可能引起该故障的原因，并据此排除该故障。

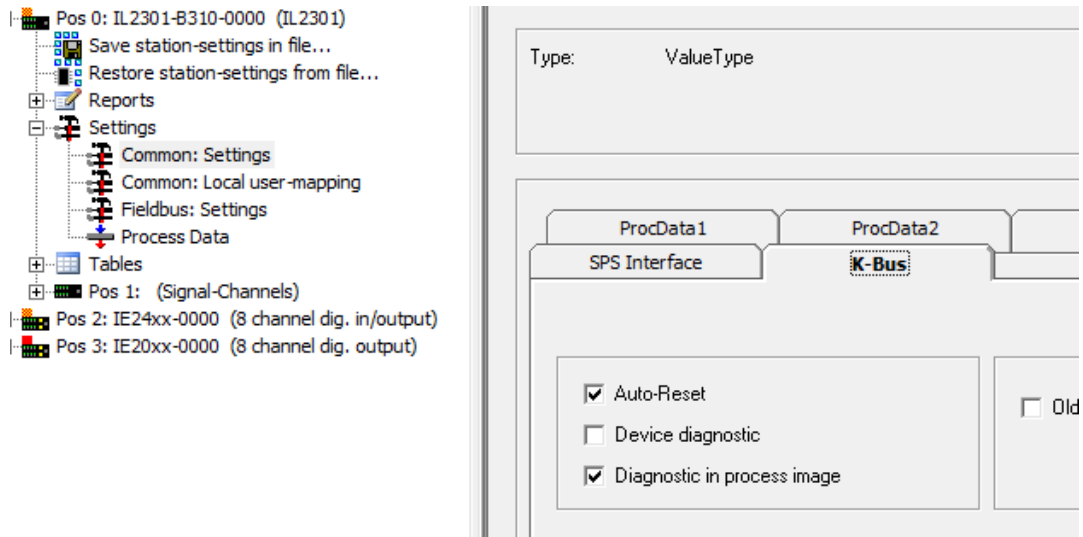
图 3: KS2000 设置界面

当故障排除后，默认情况下我们需要对 IP67 模块重新上电后方能解除故障 LED 灯的闪烁状态，使其恢复到正常工作的指示状态。那么，是否有什么方法可以无需重新上电即可使指示灯回复正常状态，即 IP-Link 的通讯自动恢复？答案是肯定的。

通过设置耦合器或 PLC 端子盒（IL23xx-xxxx）的内部的一个选项“K-bus Auto-Reset”（图 3）即可实现。

通过 KS2000 设置 Auto-Reset 后,我们可以如此测试效果:拔出任何位置 IP-Link 的光纤线,当故障指示灯闪烁报警后,将光纤线重新插回(故障恢复),在经过几秒钟后,故障指示消除,恢复至正常工作状态,即表示 Auto-Reset 已经生效。

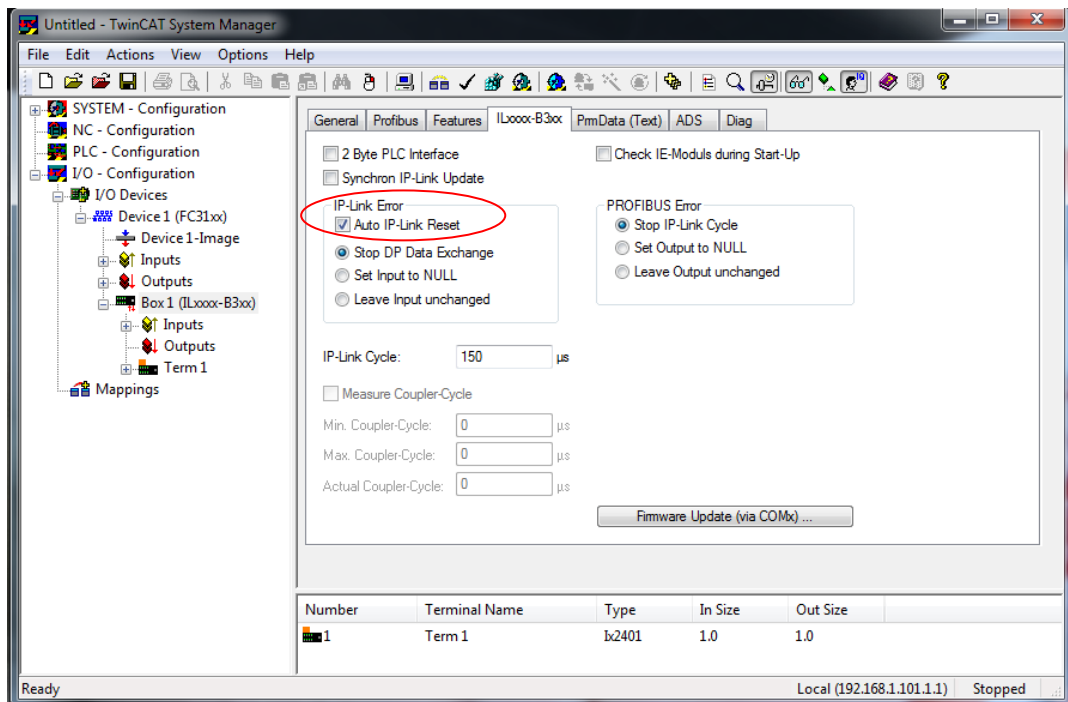
图 4: 主站采用 Beckhoff 总线板卡 FC3101

注意: KS2000 设置 Auto-Reset 只在总线通讯未连接的情况下可以生效,若现场总线已连通,则此时我们会发现 KS2000 中设置 Auto-Reset 不能成功,在这种情况下,我们需要做下面的设置。

以 Profibus_DP 通讯为例, DP 主站分别采用 Beckhoff 总线板卡 FC3101 及西门子 S7-300 CPU,此时 Auto-Reset 在 DP 主站中设置:
